# Overview of YES Dropsonde Performance During CPEX and YES QC

S. Greco, G.D. Emmitt and M. Garstang  
Simpson Weather Associates, Inc.

**CPEX Science Team Workshop**

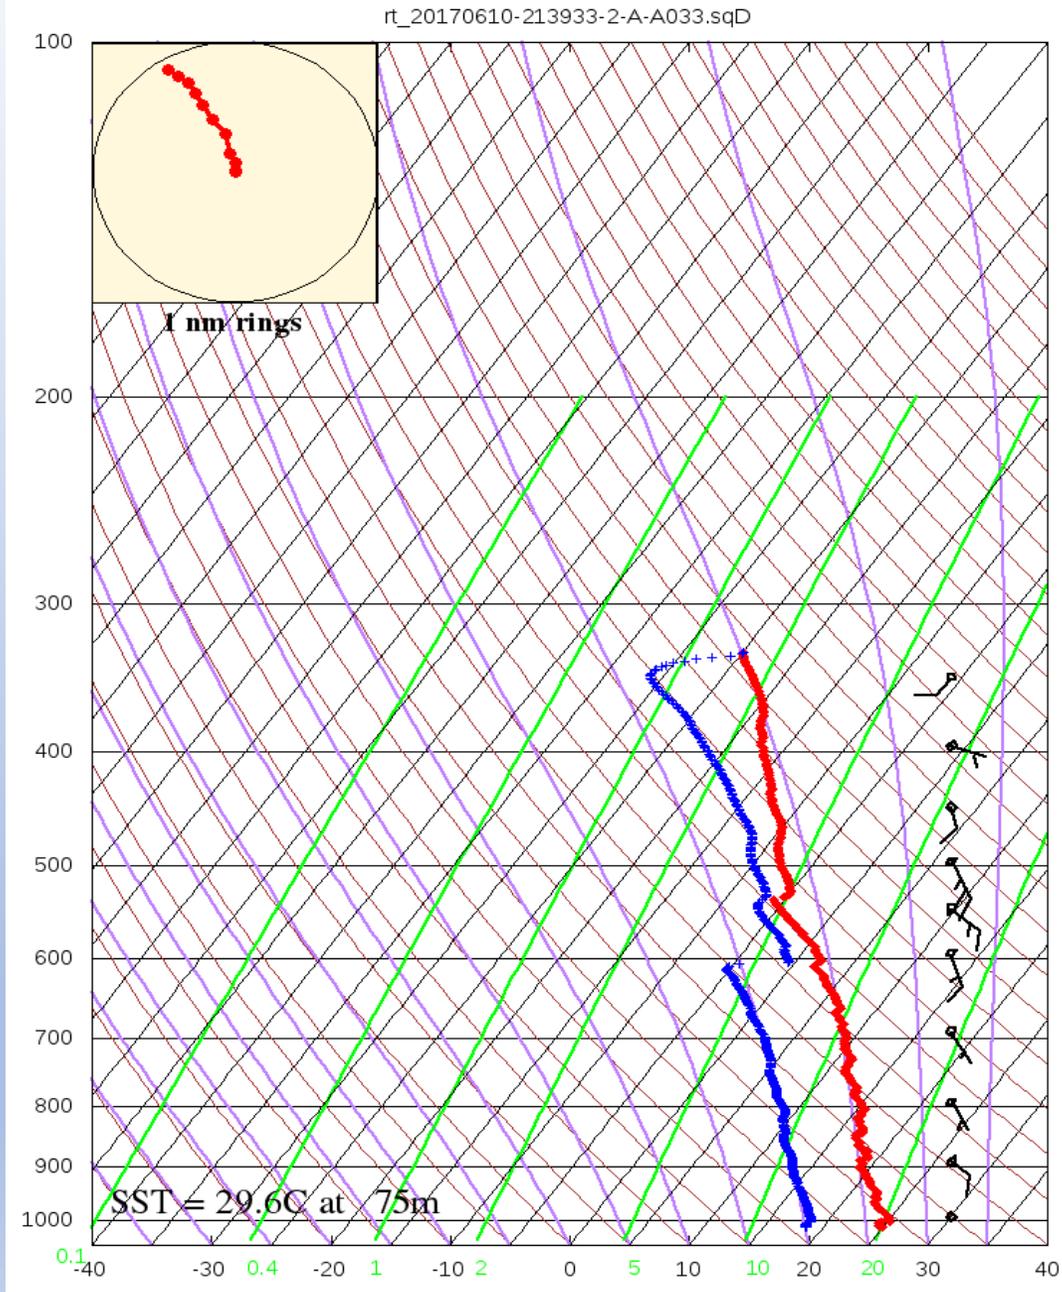
# Example of Moisture “Jump”

- GPS/LAT/LONG jumps within profiles (fixed as of 04/18)
- Moisture “Jumps” or Discontinuities
- ???????

- RH of sensor at sensor temperature found to never exceed 95% or go below 5% (sensor limitation).
- RH measurement shifted dramatically, without recovery, on at least 6 sondes.
- Best guess: water got to leads on RH sensor, shifting capacitance measurement.
- RH measurement on other drops shifted, but then recovered (water on sensor?)
- A hydrometeor shield for the RH sensor was designed and implemented during the latter part experiment and will be used in future deployments.

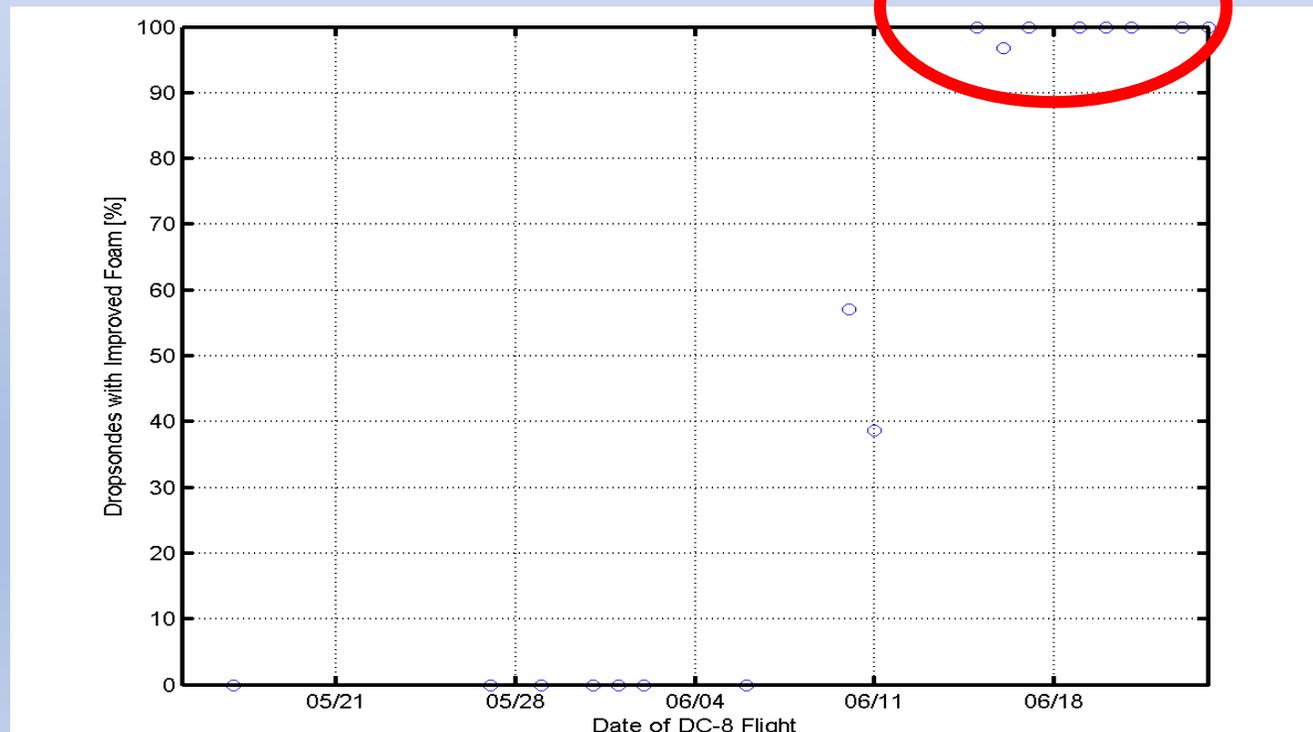
- The packaging of the sonde was improved by denser foam and better sealing after the first week of CPEX
- YES installed a replacement receiver with improved shielding before the June 20 flight
- As seen in the Figure 1, the over 97% of all possible packets were received on 6/20, 6/21, and 6/23.

After the installment of a replacement receiver with improved shielding before the June 20 flight, only 4 out of 64 sondes experienced telemetry issues

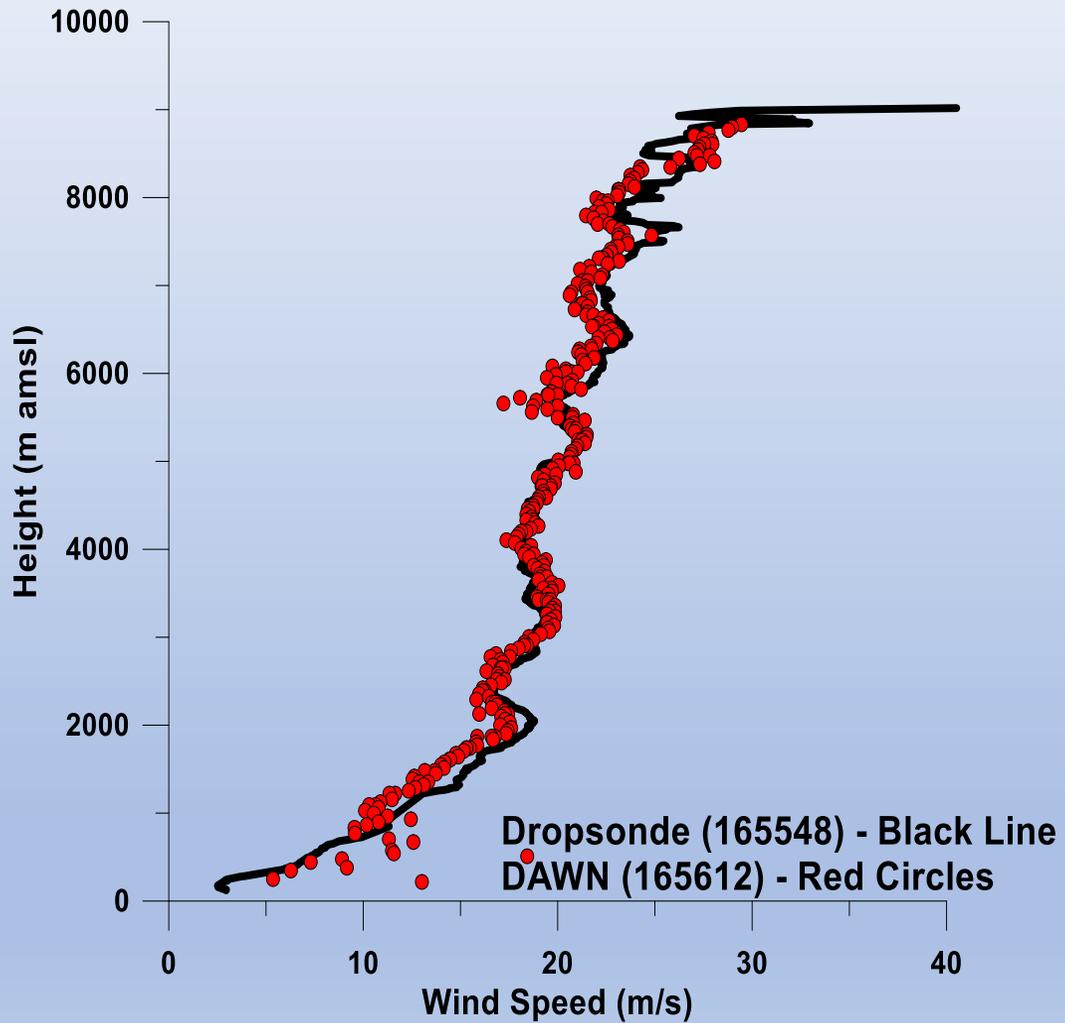
### CPEX DAWN - DROPSONDE COMPARISON

Wind Speed

06/06/17

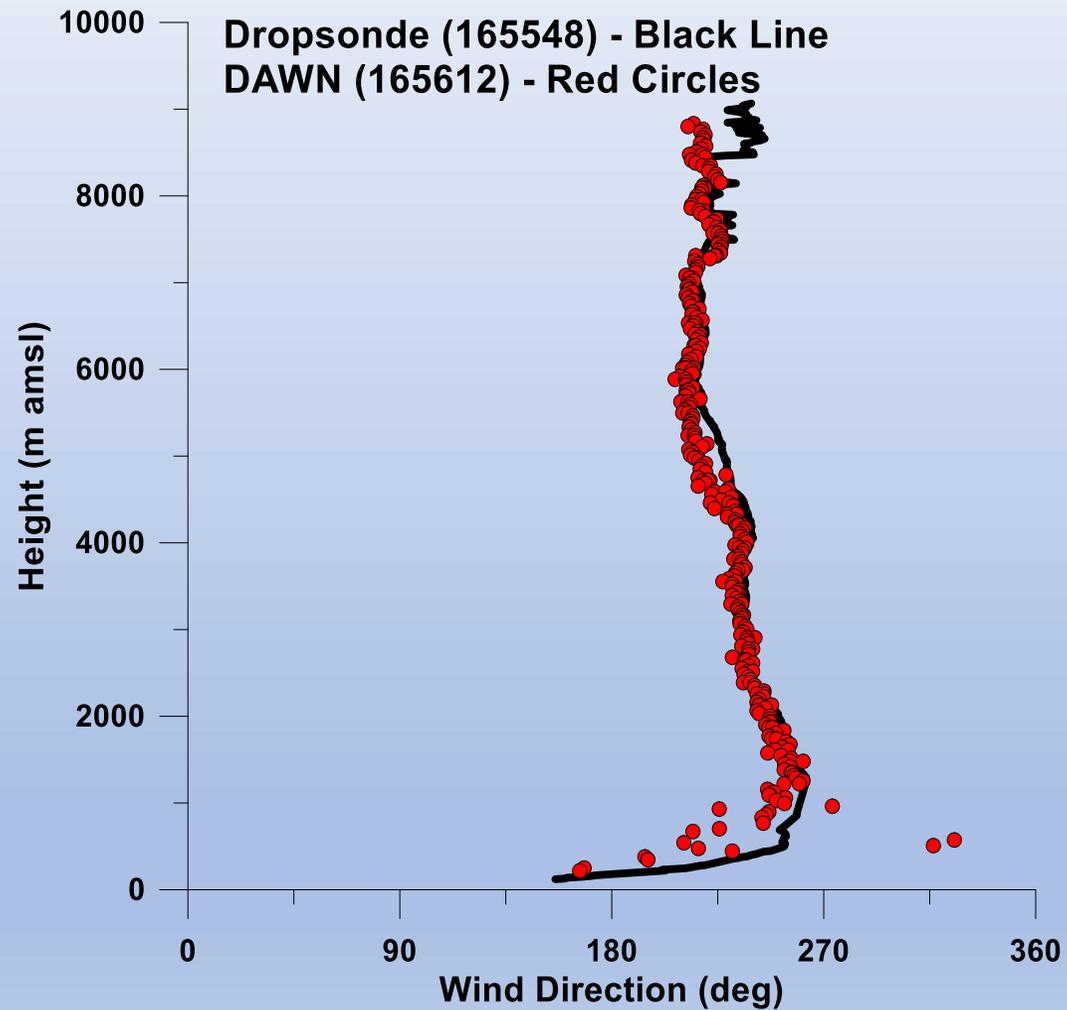
### CPEX DAWN - DROPSONDE COMPARISON

Wind Direction

06/06/17

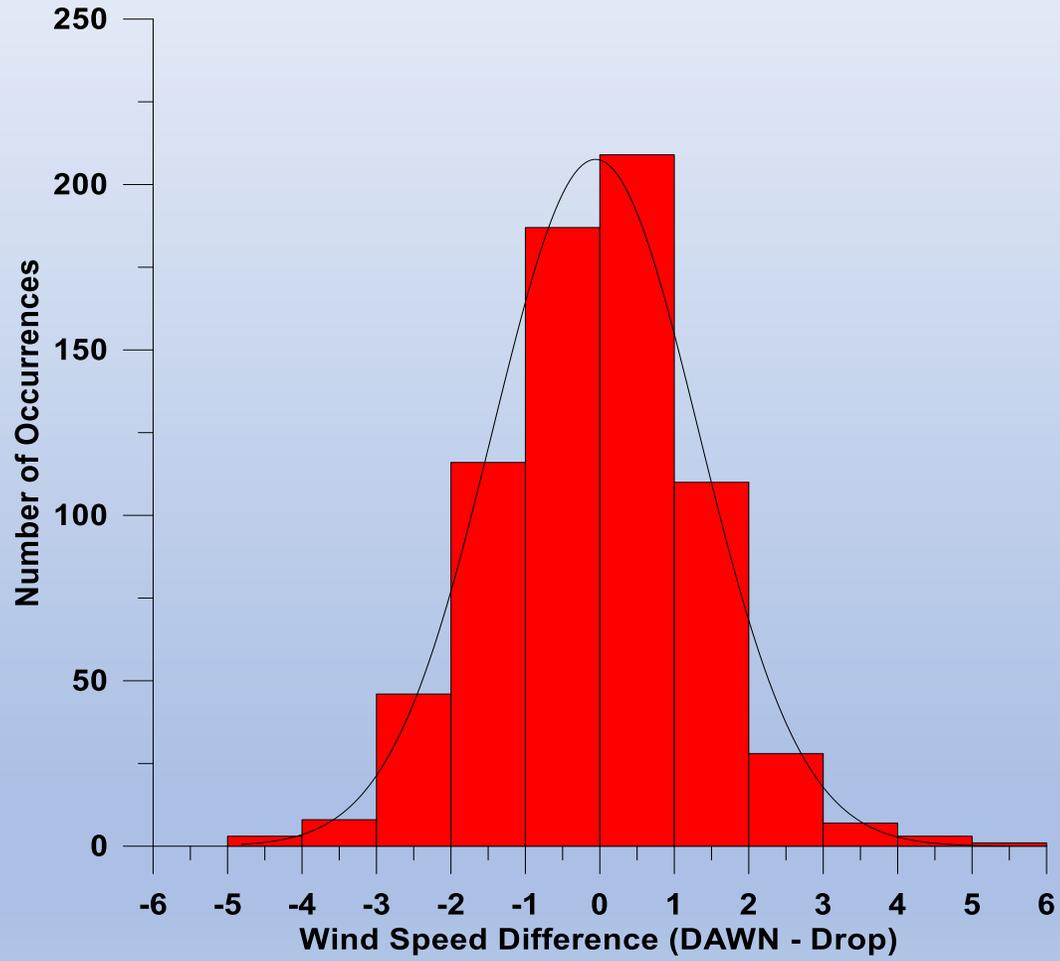
**DAWN - Dropsonde Wind Speed Comparisons  
CPEX - May 27, 2017 (All Drops) - BASE**

Note 1: Primary cause of bias is due to drift in reported heading from the true heading

Example: .1 degree heading error on DC-8 may introduce .34 m/s error in computed wind speed

Note 2: Primary reason for RMSD (root mean square differences) is spatial and temporal separation of dropsonde and DAWN samples

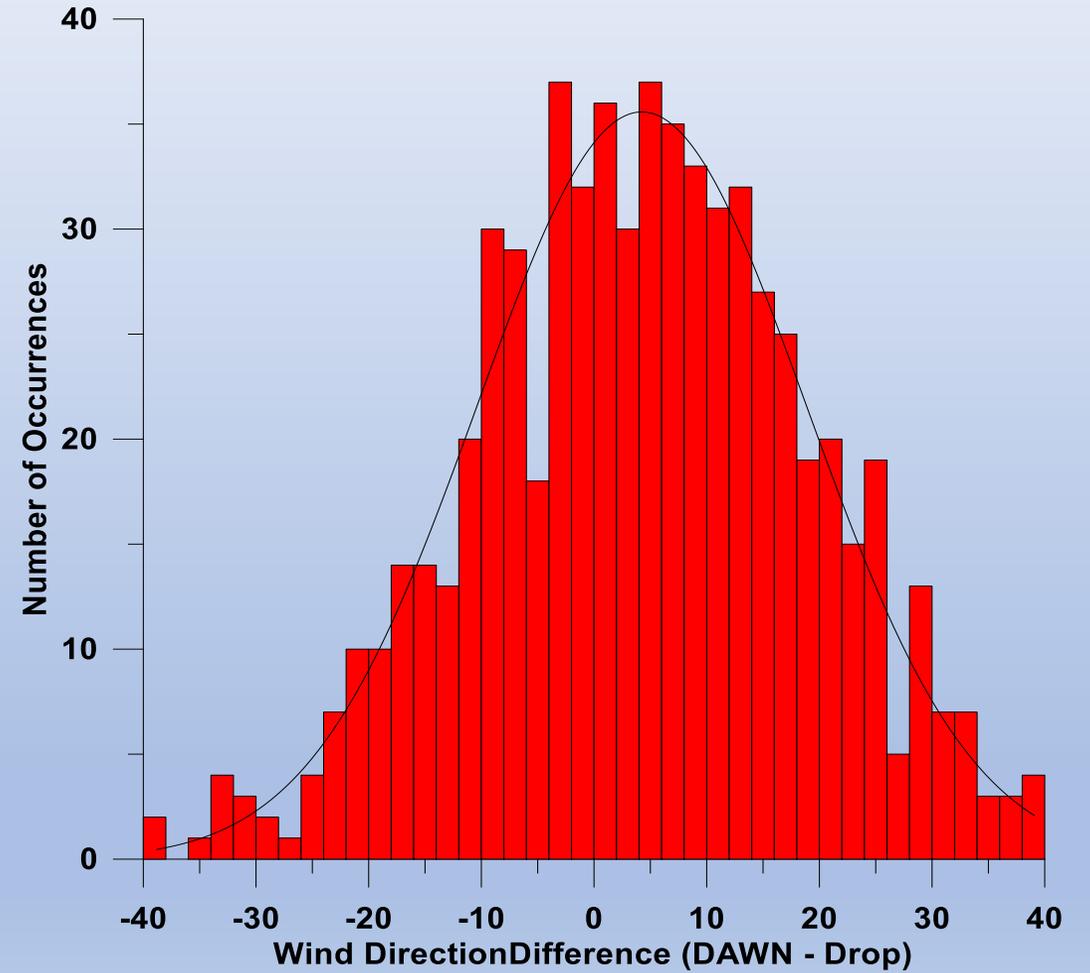
**DAWN - Dropsonde Wind Direction Comparisons  
CPEX - May 27, 2017 (All Drops) - BASE**

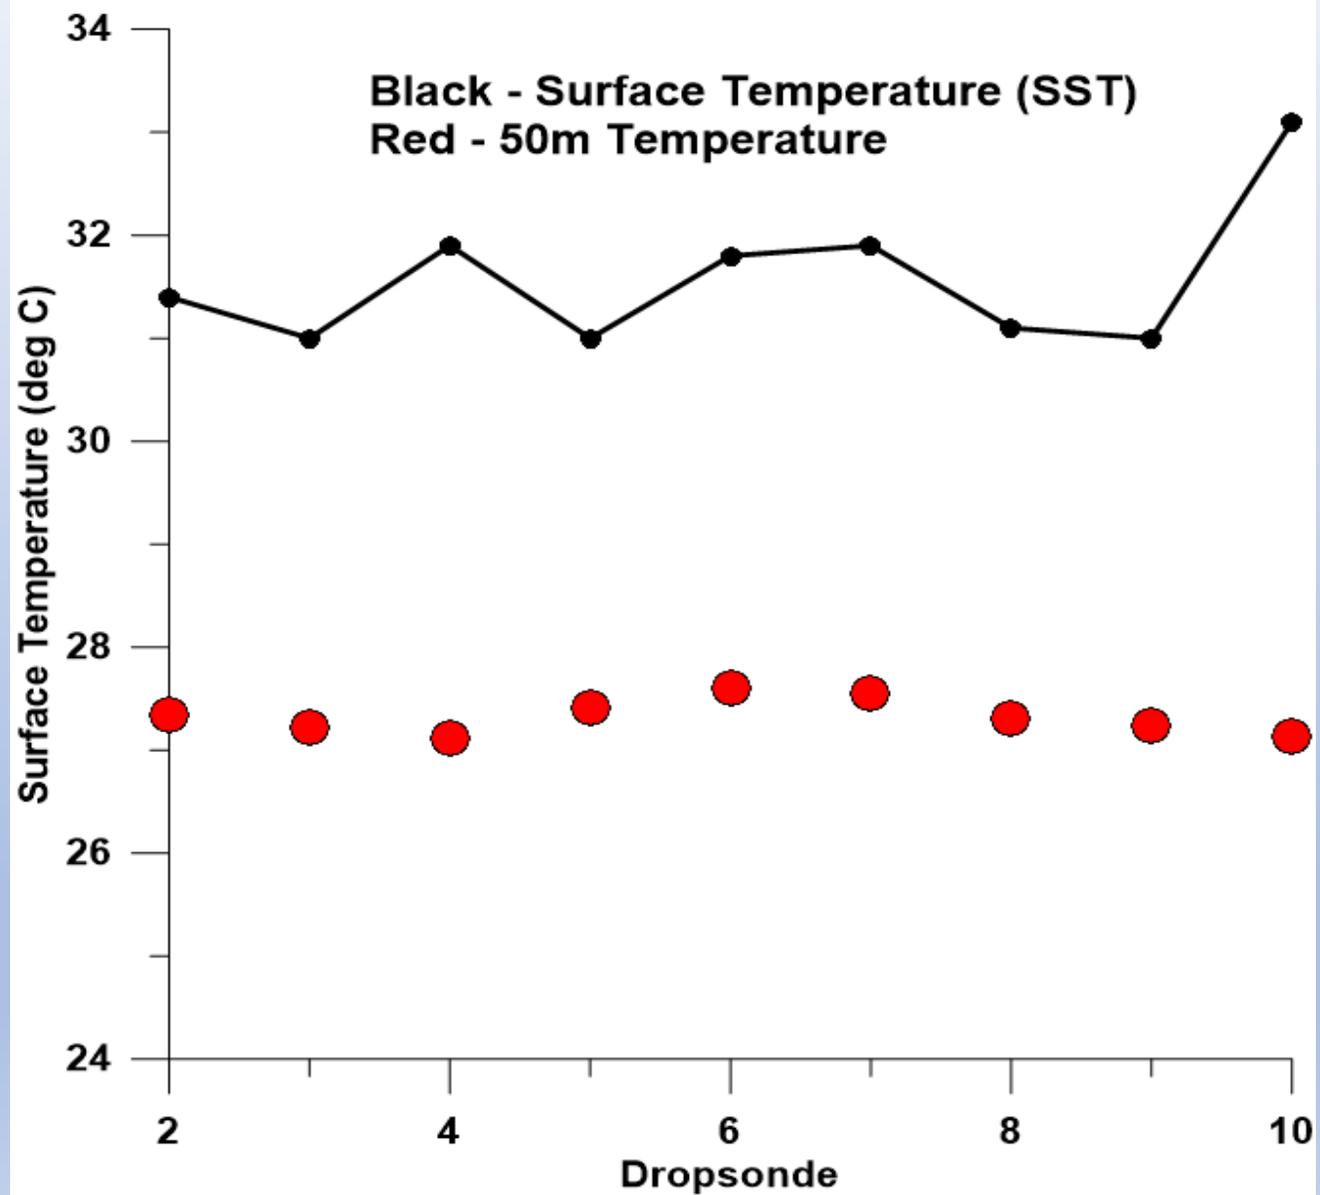
### May 27, 2017 CPEX Mission Surface Temperatures

2028/31.4 2106/31.8

2118/31.9

2039/31.9

2057/31.0

2158/33.1

2020/31.0

2140/31.0

2129/31.1

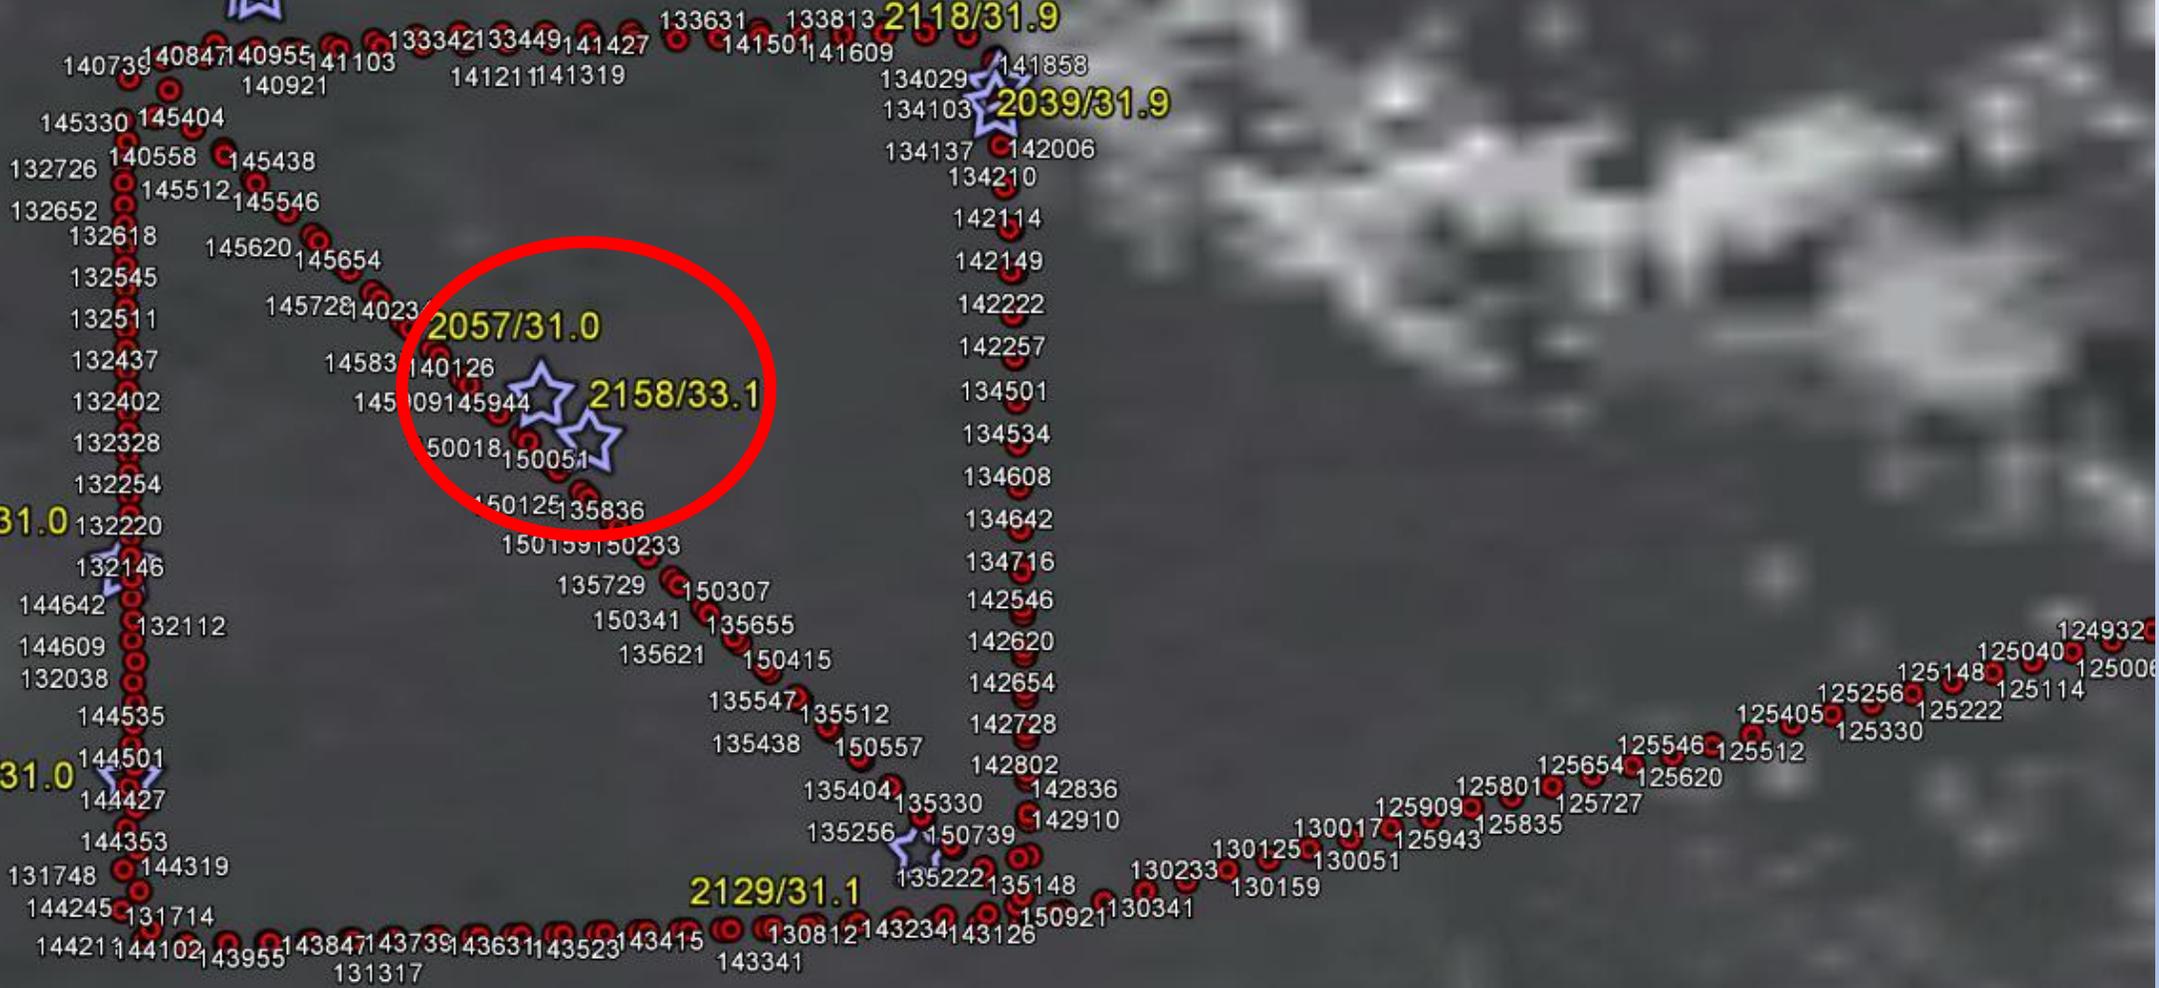
# June 10, 2017 CPEX Mission Surface Temperatures

- Sea surface temperature measured with an infrared sensor sensitive to thermal gradients within the sensor package.
- An improved sensor with gradient compensation was used towards the end of the experiment
- Better in dry conditions compared to rain

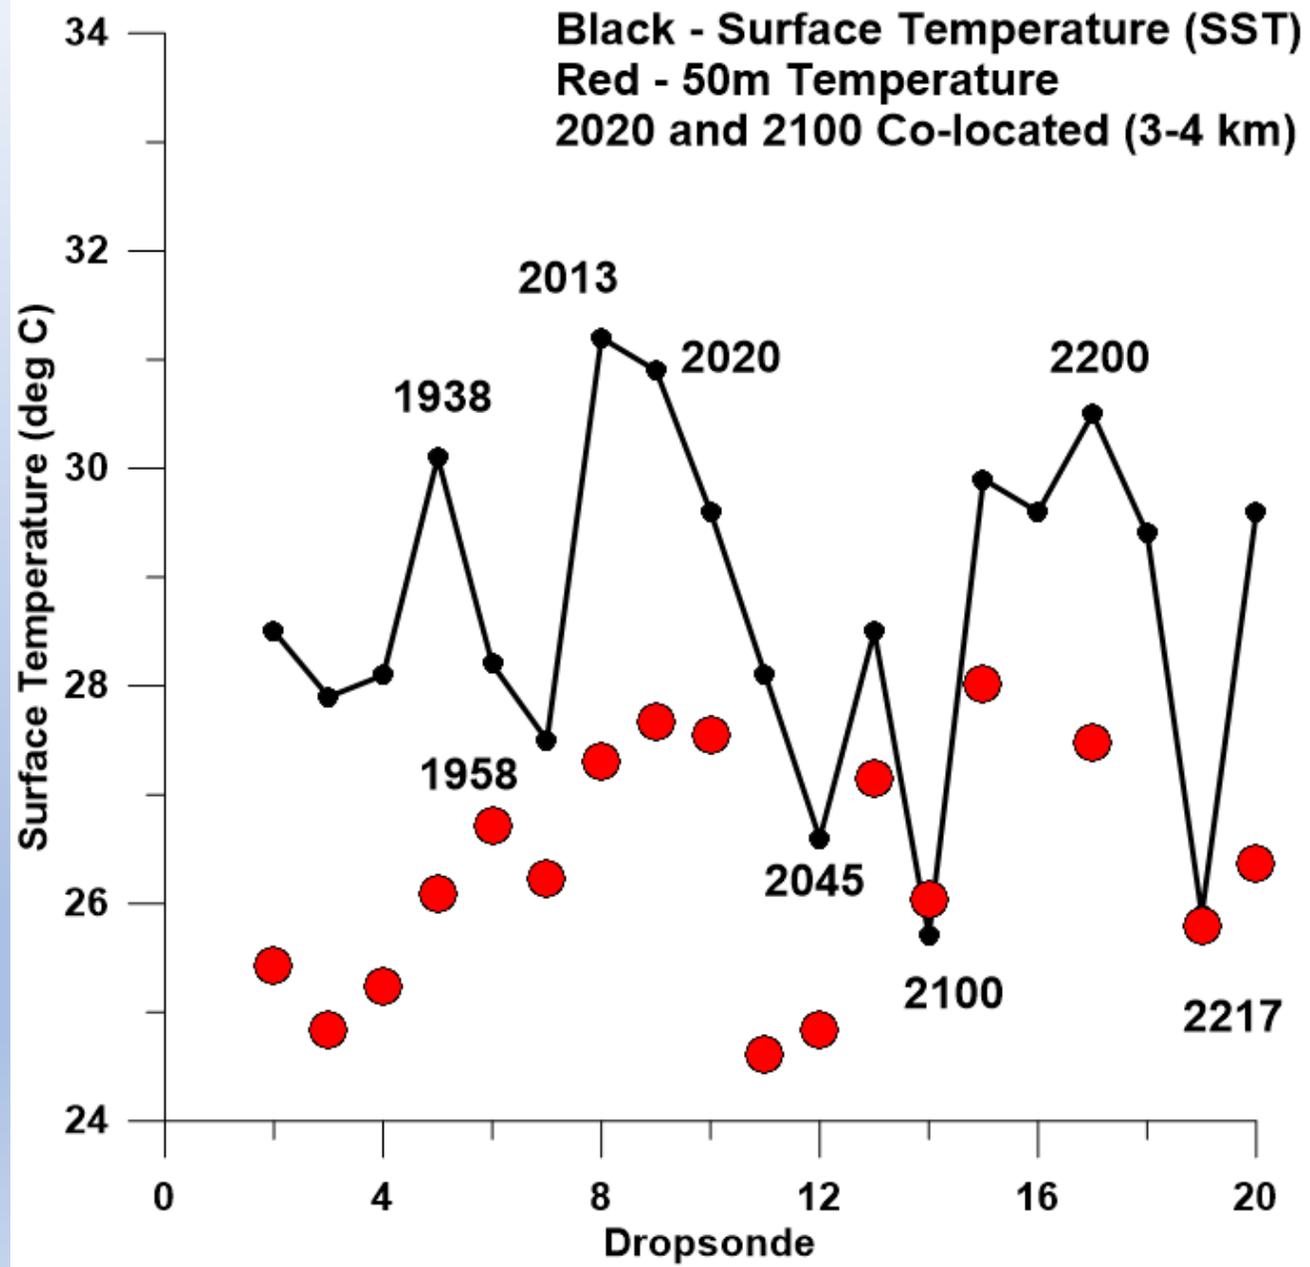
2217/25.9

1954/23.2

2045/26.6

1958/27.5

1937/30.1

2139/29.6

2037/28.1

2050/28.5

2201/29.4

2013/31.2

2031/29.6

2200/30.5

2110/29.9

2100/25.7 2020/30.9
